Martin Brogie, Inc.
ENVIRONMENTAL SERVICES

**Response to Staff Comments
for
Proposed Wetland Restoration Plan
25 Kane Street
West Hartford, Connecticut**

**Thomas R. Evans
271 West Pond Meadow Road
Westbrook, Connecticut
06498
April 23, 2020**

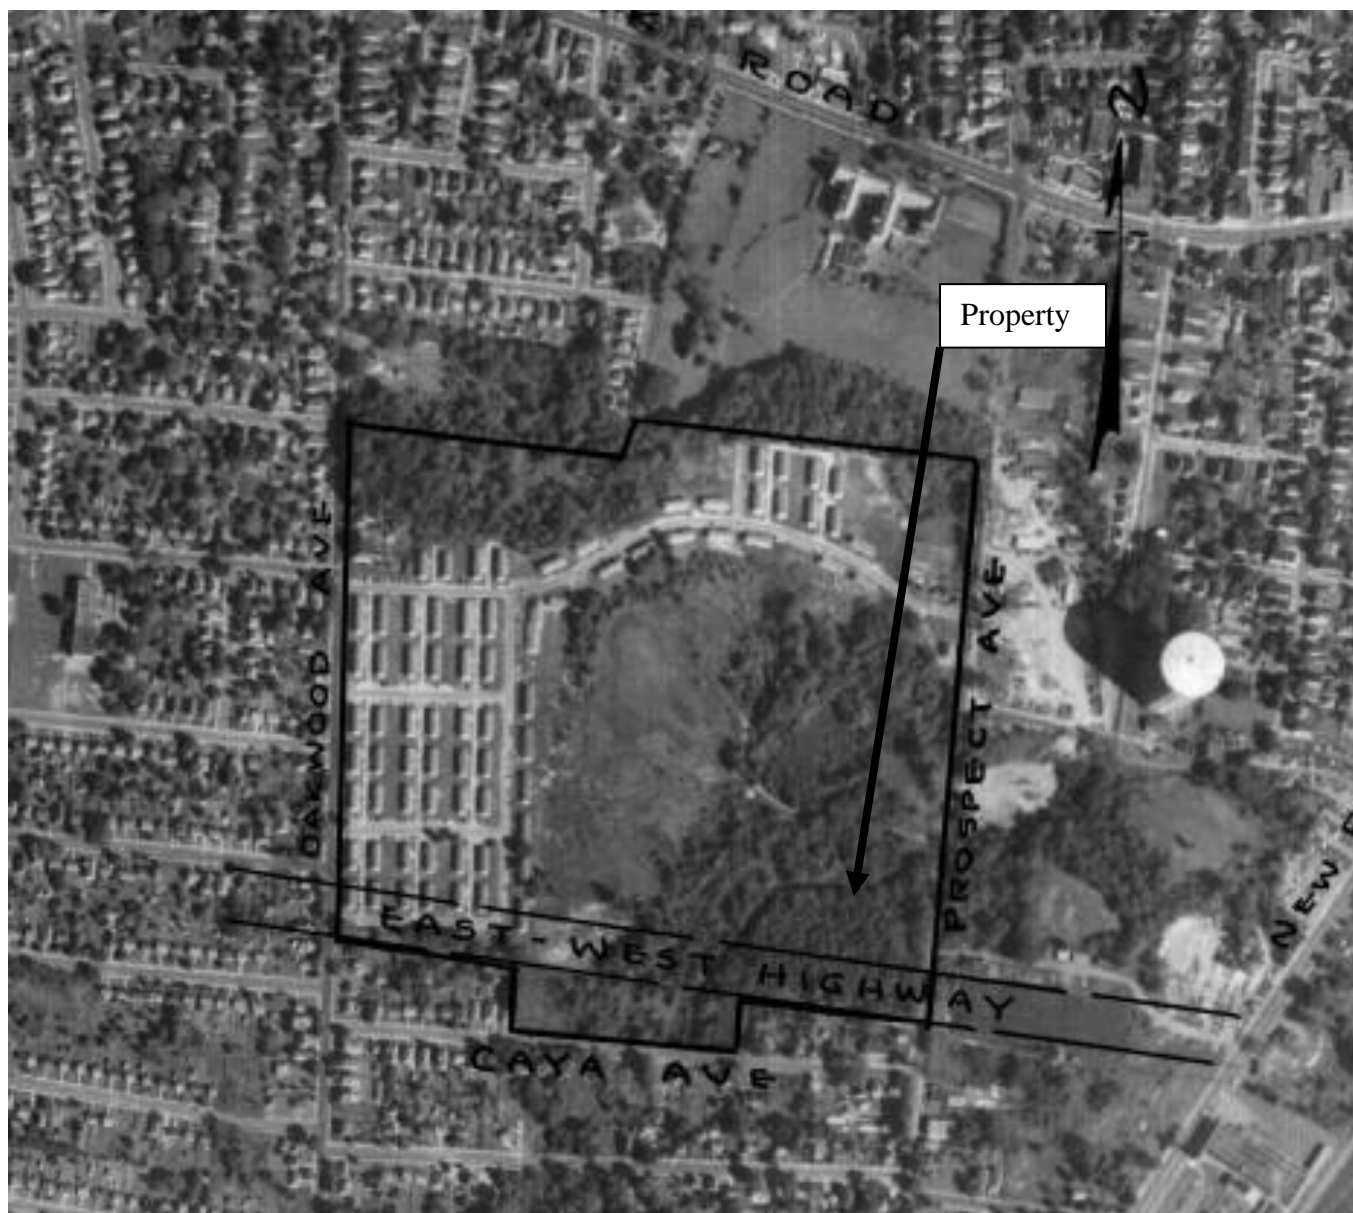
1951 Aerial Photograph (UConn Magic)

The Natural Resource Conservation Service WEB Soil Survey indicates that the Property soils consist of Udorthents which are man-made/filled areas. Site topography suggests the presence of fill materials along the highway right-of way, along Prospect Street and along the northern, developed portion of the Property. Sandy soils were noted in these locations. Aerial photographs from 1951 and 1970 (see below) indicate that the Property was part of a forested area within a highly developed area and likely contained wetlands/watercourses. The construction of the highway resulted in the reconfiguration of the land and watercourses including importation of fill materials and creation of ditches, channels and the current course of Kane Brook through the Property as depicted in the 1970 aerial photograph.

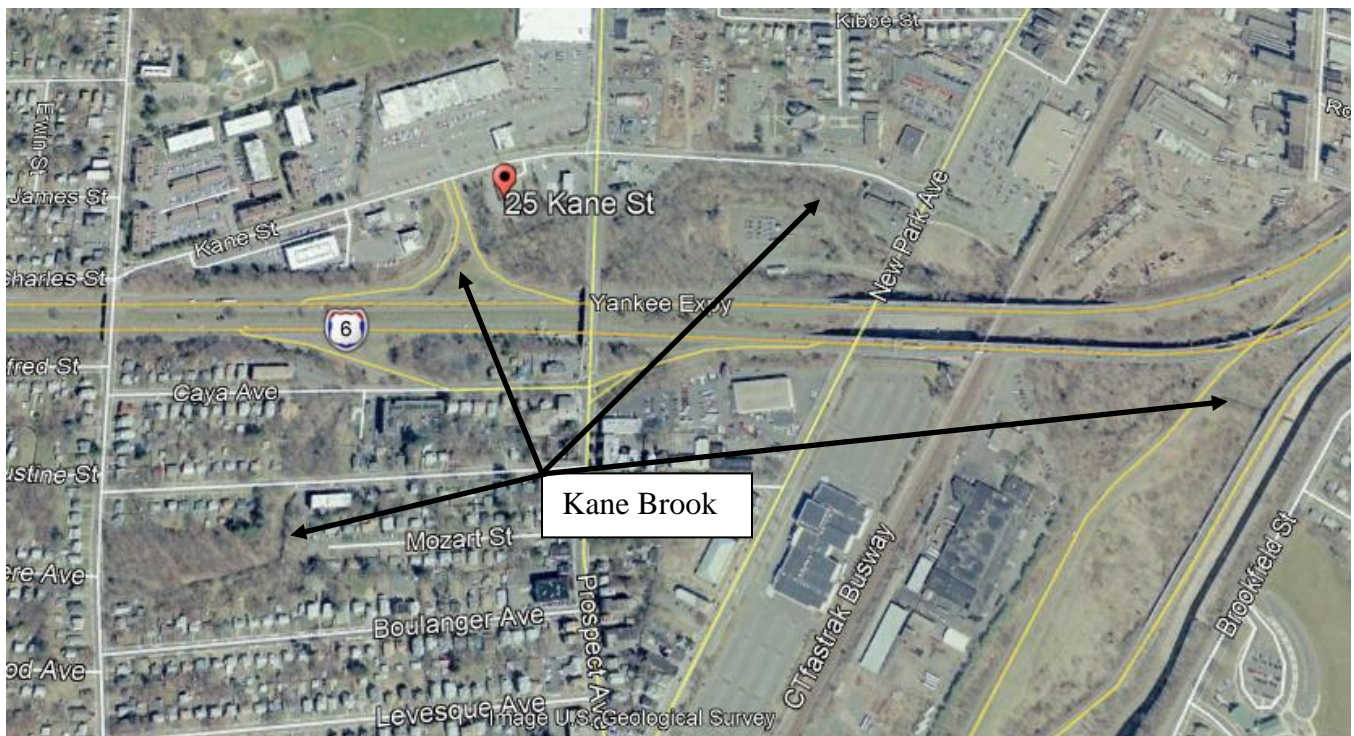
Kane Brook appears to maintain some perennial base flow although year-round observations were not completed as part of this study. Before entering the Property, the brook is culverted below I-84 to the southwest and is an open channel for approximately 1400 feet before being culverted below Oakwood Avenue. The brook daylights again to the northwest of the Oakwood Avenue culvert at the rear of residences north of Edgemere Avenue. After exiting the Property, the brook flows eastward through a wooded area, passes below New Park Avenue, I-84 and the busway before entering a forested area and then the I-91 corridor. It discharges to the East Branch of the Park River approximately 2700 feet east of the Property (See GOOGLE aerial image below).
